The Ohio Valley Coal Company
ARP R-360-70
Environmental Specialist Review
R. Scott Stiteler
9-21-2010
Revised 11-19-10

SUBSIDENCE CONTROL PLAN

Mitigation & Repair of Damage from Mining Beneath Belmont RCAG

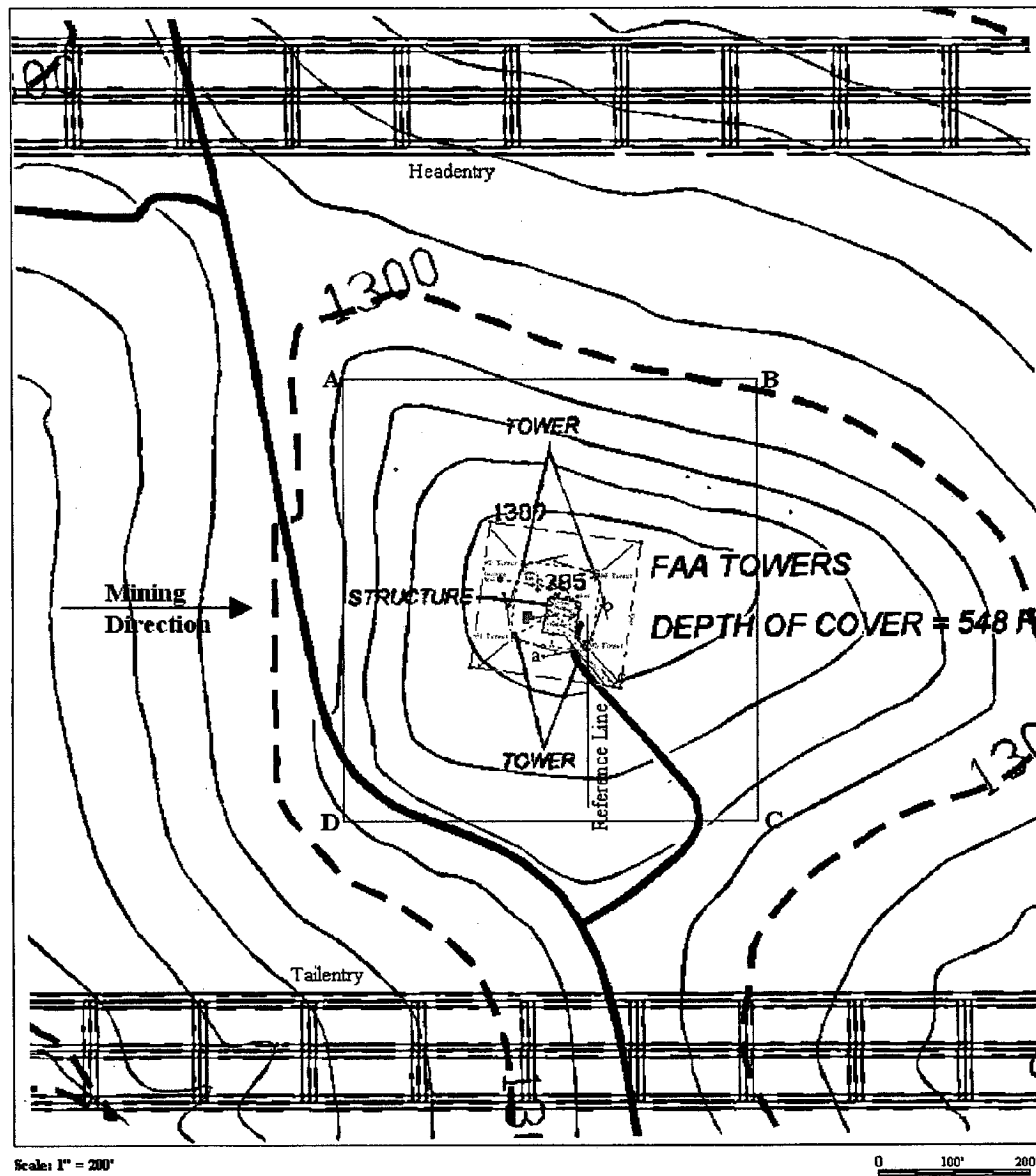
Fig. 1 Overview of the Subsidence Study Site

The portion of the longwall panel over which the property is located is shown in Fig. 1. The longwall panel is 1,168 ft (rib-to-rib) and the mining height in the Pittsburgh coal seam is about 6.25 ft based on past mining experience. The headentry of the panel is on the north side (upper side in the figure). The mining direction in the panel is from west to east (left to right in the figure).

The surface topography in the area is also plotted in Fig. 1 as well as shown in a 3-D surface image generated from Google Earth. It shows that the property is located in a relatively flat area on the top of a gentle hill. The surface elevation at the equipment building is 1,385 ft while the overburden depth at this location is about 548 ft. The variation of elevation within the fenced property is only a few feet.

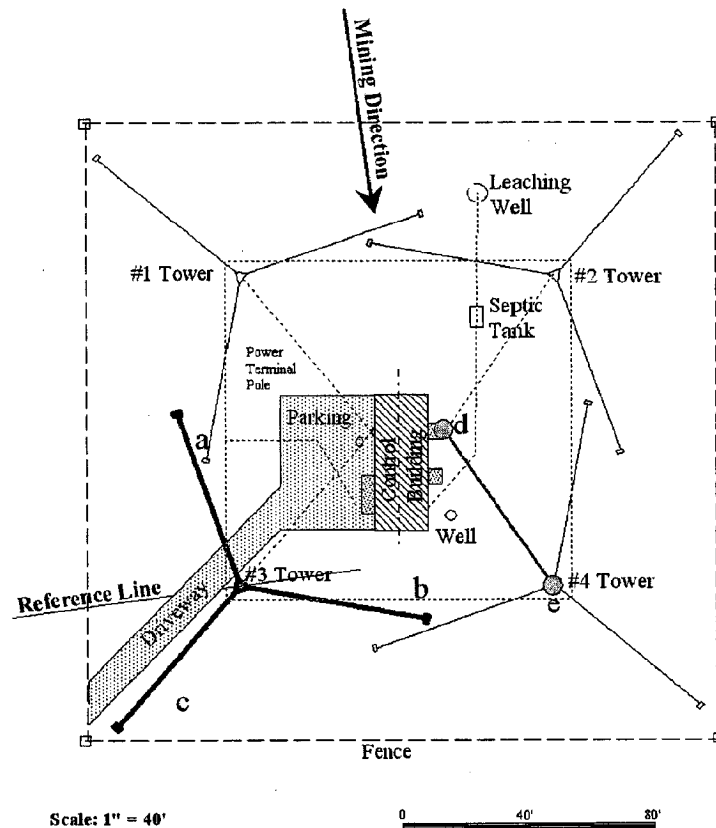
Fig. 3 Structures within the Property

The fenced property is a square area with its side length being 200 ft as shown in Figs. 3 and 4. The three main structures inside the property to perform the air to ground communication functions are:

In addition to the main structures, the other structures within the property include, a water well (depth unknown) located a short distance behind the equipment building, a septic tank, a leaching field, a power terminal pole and a small asphalt paved parking lot as shown in Fig. 3. The power lines attached to the pole (Fig. 14) show sufficient sag for the anticipated subsidence event.

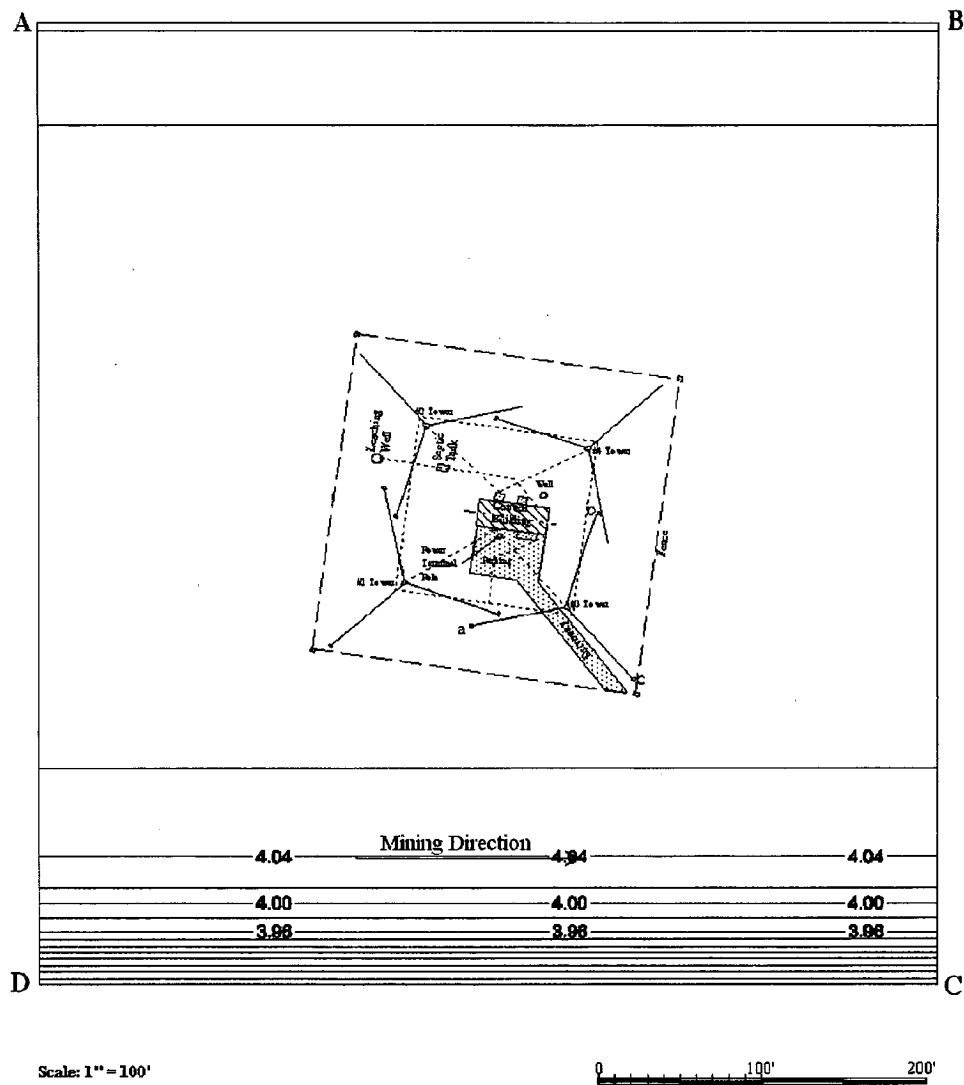
Fig. 15 Predicted Final Surface Subsidence in the Area around the Property

Figure 15 shows the predicted final surface subsidence in the specified area. It shows that the entire property is located in the flat bottom portion of the final subsidence basin to be formed over the longwall panel. The final subsidence to be experienced by the entire property is a uniform 4.08 ft.

Based on the final subsidence prediction, the mine design met its original requirement to place the property in the flat bottom portion of the final subsidence basin to be formed over the longwall panel. The land surface will be approximately four (4) ft lower after subsidence.

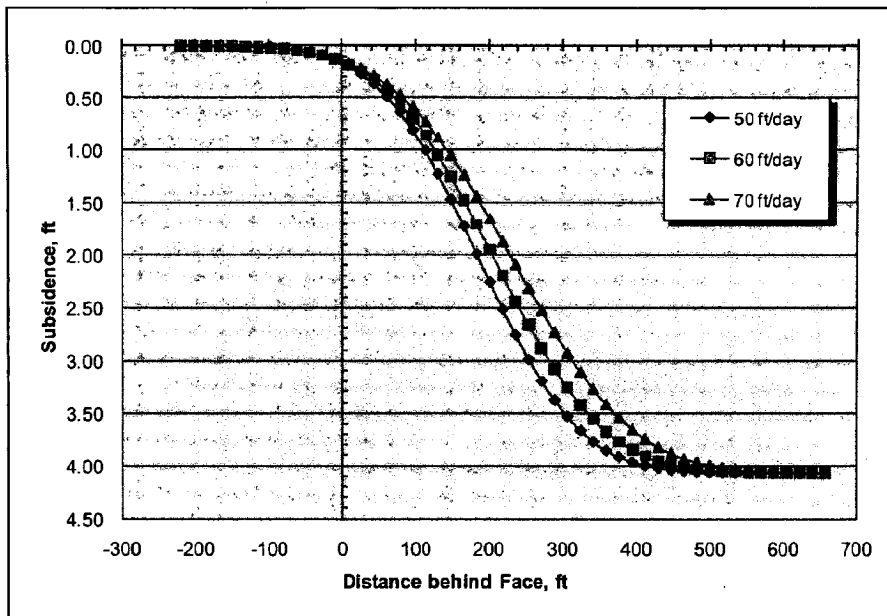
Fig. 20 Development Curves of Predicted Dynamic Subsidence

Figure 20 shows the development curves of the dynamic subsidence at the prediction point. It shows that a faster face advance rate generates a gentler subsidence development curve. There would be a small subsidence before the longwall face reaches directly under the surface point. The subsidence process accelerates afterwards and reaches about one half of its final subsidence when the longwall face is between 180 and 230 ft past (outby) the surface point. At the same time, the dynamic subsidence process is most active. A decelerating subsidence process follows and the ground surface reaches the predicted final subsidence when the face is about 600 ft outby the surface point of interest.

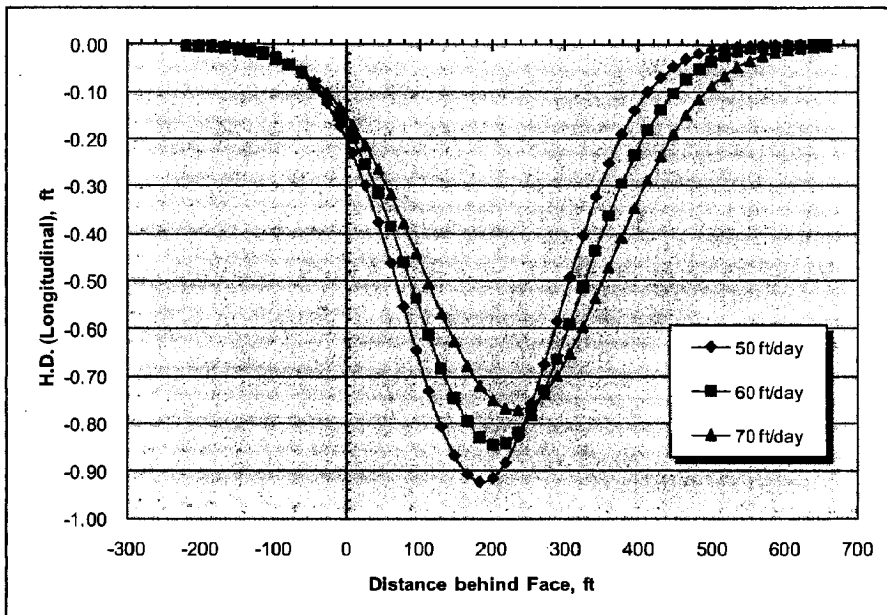
Fig. 21 Development Curves of Predicted Dynamic Horizontal Displacement (Longitudinal Component)

The predicted development curve for dynamic horizontal displacement (longitudinal component) at the selected point is also plotted in Fig. 21. The negative value in the figure indicates that the movement is against the mining direction. The maximum dynamic horizontal displacement ranges from 0.77 to 0.92 ft when the longwall face is between 180 and 230 ft outby the surface point of interest. Figure 21 also shows that the higher the advance rate, the smaller the maximum dynamic horizontal displacement will be. The ground regains lateral stability when the longwall face has past the surface point of interest a distance of 700 ft.

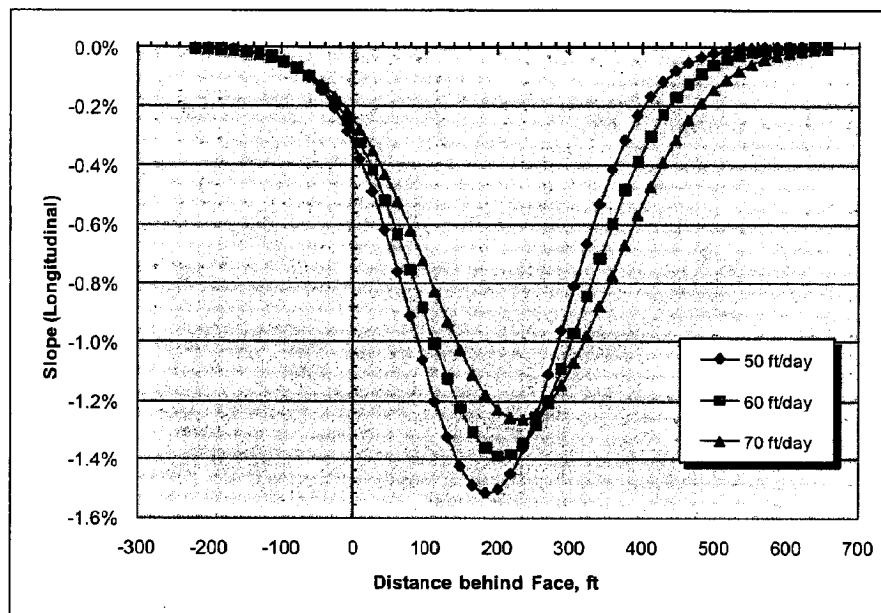
Fig. 22 Development Curves of Predicted Dynamic Slope (Longitudinal Component)

The predicted development curve of dynamic slope (longitudinal component) is plotted in Fig. 22. It has the similar distribution pattern as the dynamic horizontal displacement. The maximum dynamic slope ranging from 1.26% to 1.52% occurs between 180 and 230 ft behind the longwall face. The ground surface at the location of the building regains its “levelness” after the longwall face is 700 ft past the surface point.

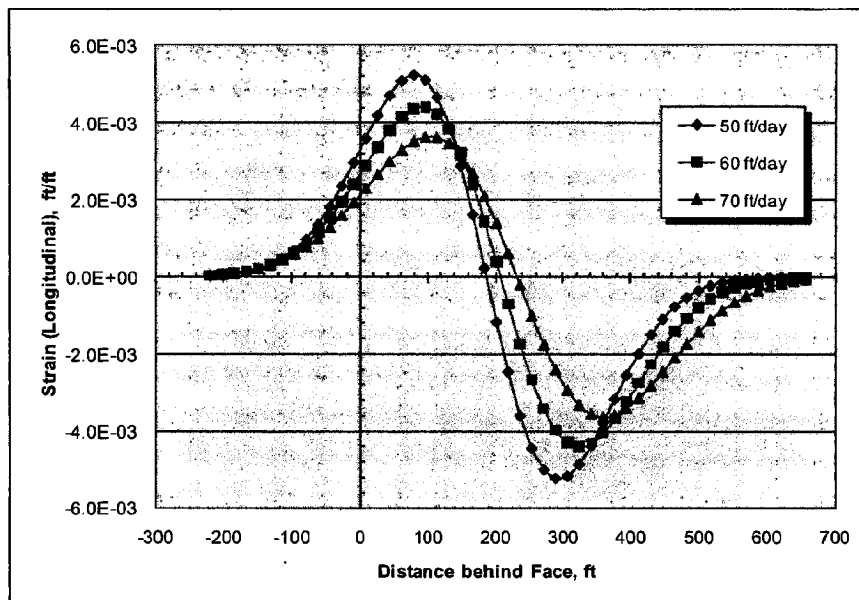
Fig. 23 Development Curves of Predicted Dynamic Strain (Longitudinal Component)

The predicted development curve of surface dynamic strain (longitudinal component) to be experienced by the equipment building is plotted in Fig. 23. It shows that the ground surface would begin to experience tensile strain when the face is still 150 ft inby the point of interest. The tensile strain would increase as face retreats closer to and passes the point. The maximum dynamic tensile strain, ranging from 3.63×10^{-3} to 5.23×10^{-3} ft/ft, would occur when the longwall face is between 75 and 95 ft outby the point of interest. It also shows that the higher the face advance rate, the smaller the maximum tensile strain. Then the tensile strain would reduce and becomes strain free when the face

is between 180 and 230 ft past the location. A compressive strain condition would follow and the maximum compressive strain of -3.63×10^{-3} to -5.22×10^{-3} ft/ft would occur when the face is between 290 and 350 ft outby the point of interest. The ground becomes strain free after the face has past the point of interest a distance of about 700 ft.

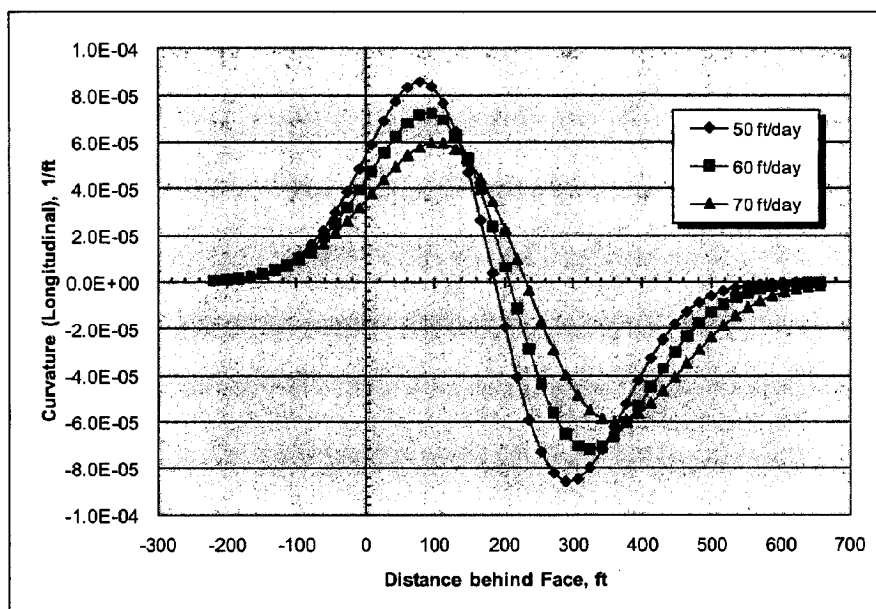
Fig. 24 Development Curves of Predicted Dynamic Curvature (Longitudinal Component)

The development curve of surface dynamic curvature (longitudinal component) at the equipment building is shown in Fig. 24. The distribution of the dynamic curvature is similar to that of dynamic strain. The maximum dynamic convex curvature ranges from 6.0×10^{-5} 1/ft to 8.6×10^{-5} 1/ft while the maximum dynamic concave curvature is between -5.8×10^{-5} to -8.6×10^{-5} 1/ft.

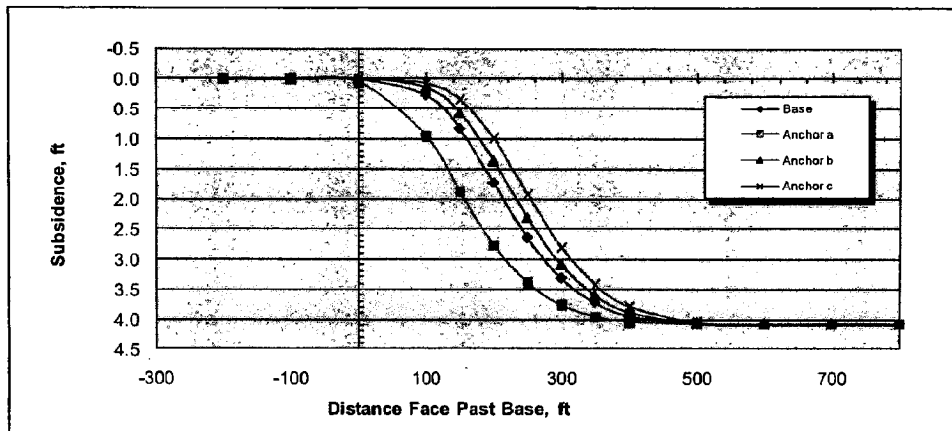
Fig. 27 Predicted Dynamic Subsidence

Figure 27 shows the predicted subsidence development curves at the four points of interest. Insignificant amount of subsidence will be experienced by the tower structures when the longwall face is directly under the tower base. The subsidence process will be very active when the face is between 100 and 300 ft past the tower base. The ground begin to regain stability after the face has past the tower base a distance of 600 ft. The figure also shows that the largest differential subsidence occurs between anchor point a and other points. However, when the final subsidence is reached, all points will reach its maximum amount of 4.08 ft.

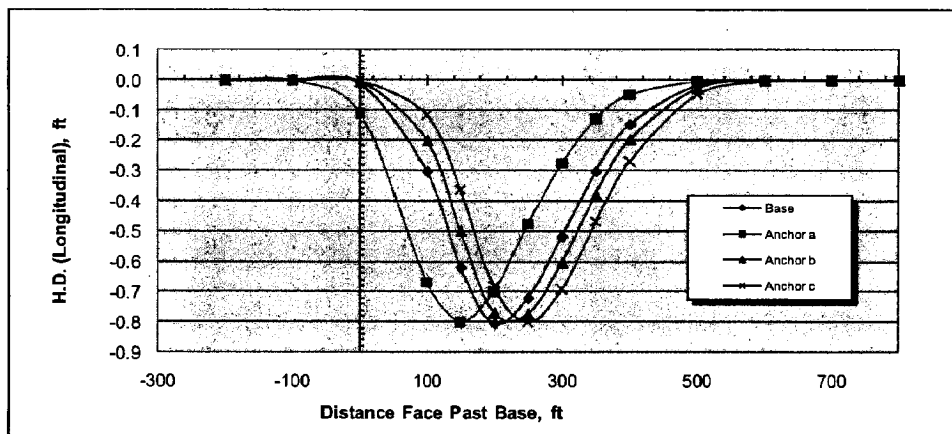
Fig. 28 Predicted Dynamic Horizontal Displacement Along Mining Direction

The predicted development curves of horizontal displacements along the mining direction are plotted in Fig. 28. The negative values shown in the figure indicate that the movements are against the mining direction.
